**Measured System Performance  
and  
Diagnostic Testing  
Report**

***U.S. Air Force Academy, Colorado  
Commissary***

**Defense Commissary Agency (DeCA)**  
Directorate of Facilities  
Facilities and Programs Division  
Fort Lee, VA

U.S. Army Construction Engineering Research Laboratories  
Champaign, IL

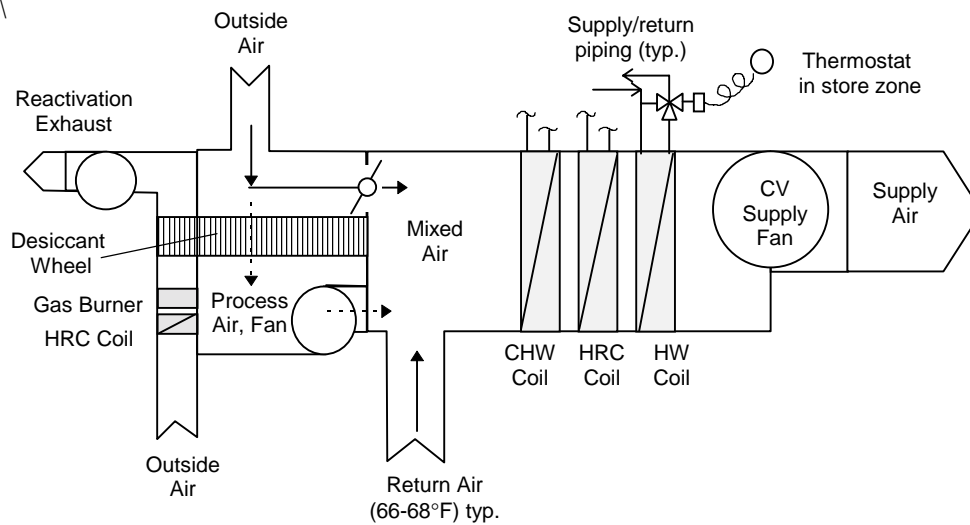
*Figure 4-1. Schematic of main store air handler w/ desiccant system*

Physical Description: The constant-volume main air handling system (DD-1) consists of a 40 hp supply fan (19 kW measured), supply and return ductwork, a 4-row chilled water coil with pneumatically-actuated 3-way modulating control valve, a hot water coil with modulating valve, and a bank of heat reclaim coils which provide auxiliary heating using hot refrigerant gases from refrigeration racks 2, 3, and 4. Chilled water coil capacity is 415,000 Btu/h and face area is 38.5 sq. ft. (35 ton nominal); hot water coil capacity is 850,000 Btu/h and 38.5 sq. ft.; and heat reclaim coil capacity is 716,000 Btu/h and 30.5 sq. ft. Return air is taken from a tunnel system below the cases to remove unwanted cold air from the refrigerated aisles. A Munters SuperAire S30 desiccant system is provided to dehumidify air taken from and returned to the mixed air chamber via a 5 hp process fan (2.8 kW measured). Dehumidified air processed by the system is thus a combination of outside and return air. A motorized damper controls outside air flow between the mixed air chamber and the desiccant system. Reactivation of the desiccant system is achieved by a heat reclaim coil (105,600 Btu/h design) from low temperature refrigeration Rack 1, followed by a 2-stage natural gas-fired in-duct furnace (400,000 Btu/h in; 308,000 Btu/h out). During desiccant operation, aftercool is supplied by the chilled water coil. Reactivation air consists of 100% outside air provided by a 7.5 hp draw-through reactivation air fan (3.9 kW measured). A small motor rotates the honeycombed desiccant wheel at 8 revolutions per hour when the desiccant system is activated. A Danfoss NC-25 RMCS is used to control HVAC system operation.

DD-1 Observed System Performance: Zone DD-1 was controlled to maintain a 72 to 73°F setpoint 24 hours per day throughout the metering period. A humidistat also was shown to maintain a maximum of 45% RH in the zone (45% zone RH - on; 40% zone RH off) in accordance with DeCA directives. Data in Figures C.2-1 and C.2-2 shows a relatively constant supply air temperature of about 72°F (with variance between 67 and 77°F minimum and maximum), and resultant temperature changes across the coil required to maintain space conditions. Analysis of this data also indicate a store 'balance point' of about 80°F outside air, below which the zone is in heating mode, and above which the zone is being cooled. Modulating valves on the hot and chilled water coils are controlled from zone temperature as follows:

Supply air temperature is thus variable, and is a function of % valve setting and % OA (assuming supply air CFM, return air temperature, and hot and chilled water supply temperatures are relatively constant). This control strategy results in rather tight control of store temperature and humidity. Through the period, store air temperature at the datalogger location varied from a value of 75°F maximum to a minimum 69°F. The above control strategy and resultant supply air temperature indicates that the flow rate of supply air far exceeds that needed for space temperature, humidity control, and ventilation requirements. Data taken during the June period indicate that the air-side of this system is in control, although improvements can be made to the control strategy (see 'Deficiencies and Recommendations' below).

Due to low ambient humidity at the Academy, the desiccant system is rarely fired. However, during those times that the desiccant portion of the DD-1 system is activated, there is a problem with fan sequencing. The problem is most likely originating in the control logic (Mr. Carlos Delarosa, 800-229-8557). Munters technical literature states that at RH setpoint, the process fan, reactivation fan, reactivation furnace, and cassette (wheel) motor should activate simultaneously. When the minimum RH point is satisfied, the process fan and burner shut down, and a user-defined 2 - 10 minute thermal purge causes the reactivation fan and wheel motor to continue. Time-series data in Figures C.2-

3 through 7 show that the process fan is operating in short cycles, while the reactivation fan and wheel motor are operating at much longer intervals. Determination of which system is in error (process or reactivation) is difficult to determine because of the use of a separate data point to surrogate the zone humidity, and due to poor calibration of the humidity sensor in the zone. The system is controlled by store ambient RH. Data show that the 45% maximum setpoint is controlled well by the system, although the reason for 'high' store humidity (in excess of 40%) warranted further investigation. Analysis of the overall operation yields the conclusion that there is no good correlation with either temperature or RH, but that the desiccant system operates when humidity ratio rises above about 0.018 lbm water/lbm dry air. At a firing rate of 400,000 Btu/h (at sea level; about 4 therms/hour) and with 6.7 kW total fan power, cost of running the air-side of this system is less than \$2/hr. This neglects the energy cost to recondition warm air introduced into the mixed air chamber. It also neglects the fact that heat reclaim could supply up to 40% of the thermal energy required for reactivation of the desiccant wheel (the heat reclaim system using hot refrigerant gas from rack 1 was not operational). Although humidity control via the desiccant system is relatively inexpensive once a system is in place, high humidity is best controlled first through judicious use of outside air and supply air to the zone, followed by use of a desiccant system (or 'dual-path' vapor compression system located at outside air intake only) to take up the difference.
